# PACSystems™ RX3i

## IC695CPU310

### Central Processing Unit

GFK-2329Q  
July 26, 2006

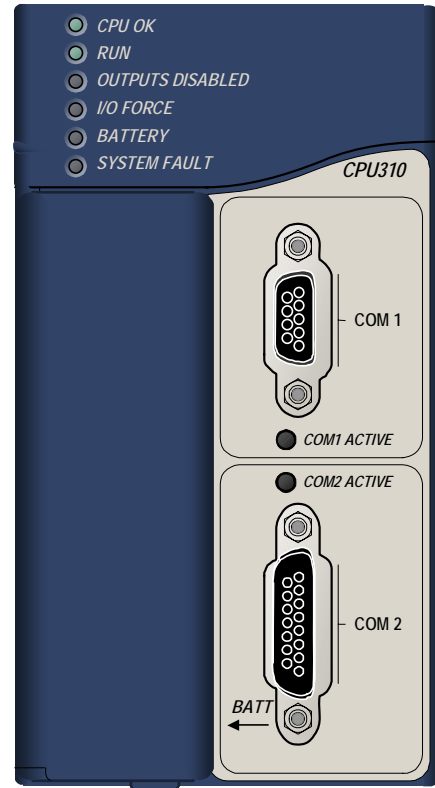
- In-system upgradeable firmware.
- Two serial ports: an RS-485 serial port and an RS-232 serial port.
- Ethernet communications via the rack-based Ethernet Interface module (IC695ETM001). For details on Ethernet capabilities, refer to *TCP/IP Ethernet Communications for PACSystems User's Manual*, GFK-2224.

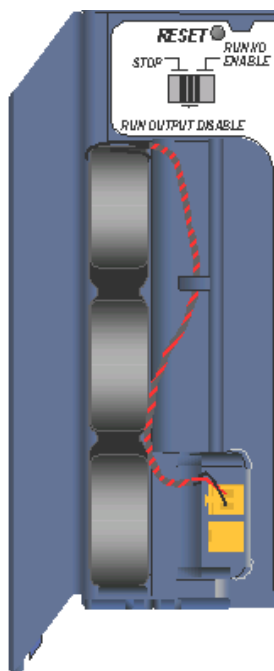
Mode Switch and Battery Compartment

To avoid loss of RAM memory contents, routine maintenance procedures should include scheduled replacement of the CPU's lithium battery pack. For information on estimating battery life, refer to the *PACSystems CPU Reference Manual*, GFK-2222.
